**DEPARTMENT OF TRANSPORTATION**

Contract #: 04-0120F4Cty: SF/ALA Rte: 80 PM: 13.2/13.9File #: 69.28**WELDING INSPECTION REPORT****Resident Engineer:** Siegenthaler, Peter**Address:** 333 Burma Road**City:** Oakland, CA 94607**Report No:** WIR-016944**Date Inspected:** 03-Sep-2010**Project Name:** SAS Superstructure**OSM Arrival Time:** 700**Prime Contractor:** American Bridge/Fluor Enterprises, a JV**OSM Departure Time:** 1900**Contractor:** Zhenhua Port Machinery Company, Ltd (ZPMC), Changxing Island **Location:** Shanghai, China**CWI Name:** Zhao Chen Sun**CWI Present:** Yes No**Inspected CWI report:** Yes No N/A**Rod Oven in Use:** Yes No N/A**Electrode to specification:** Yes No N/A**Weld Procedures Followed:** Yes No N/A**Qualified Welders:** Yes No N/A**Verified Joint Fit-up:** Yes No N/A**Approved Drawings:** Yes No N/A**Approved WPS:** Yes No N/A**Delayed / Cancelled:** Yes No N/A**Bridge No:** 34-0006**Component:** Tower Components**Summary of Items Observed:**

**TOWER JETTY**

**LIFT-3 TOWER CROSS BRACING GUSSET PLATE AT 89 M ELEVATION****WD1 – GUSA3 – 3 – 89M – S – 3A/B; 4A/B****WD1 – GUSA3 – 3 – 89M – N – 3A/B; 4A/B**

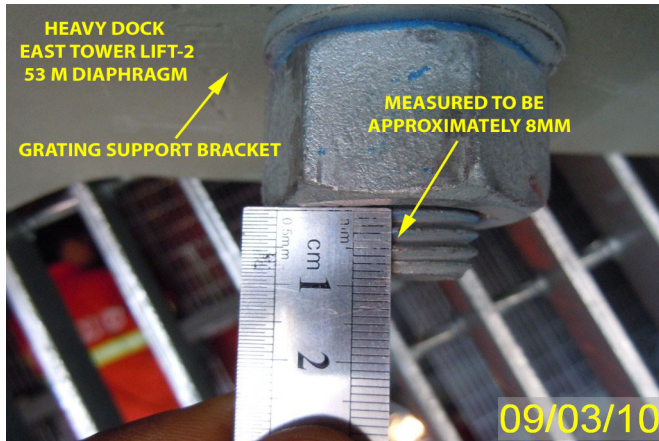
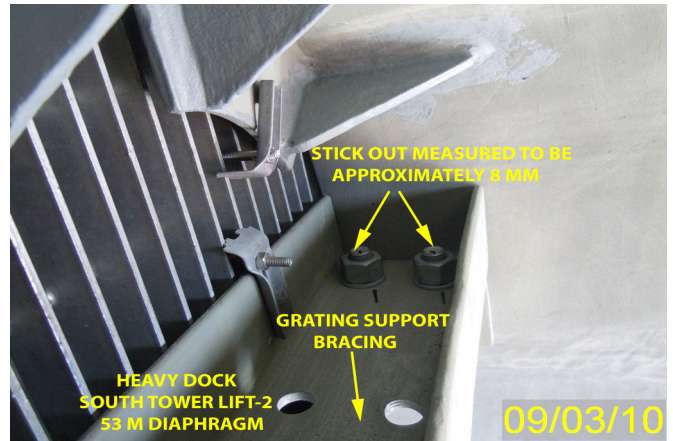
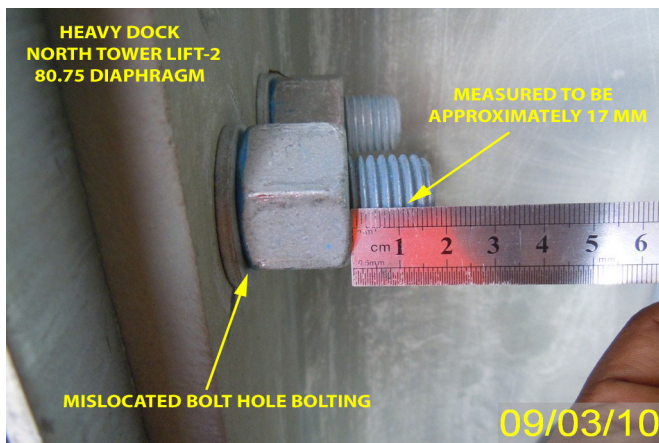
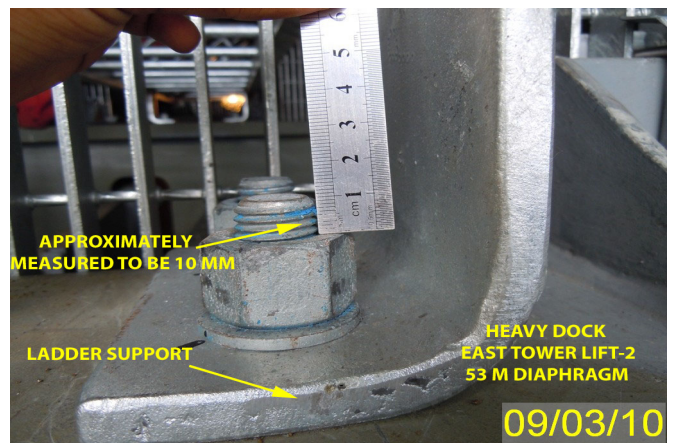
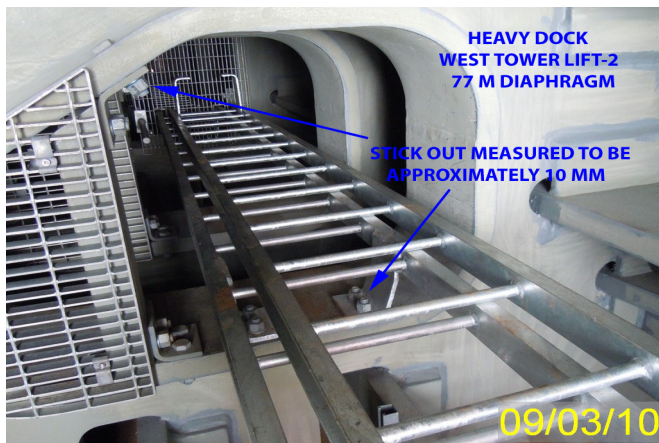
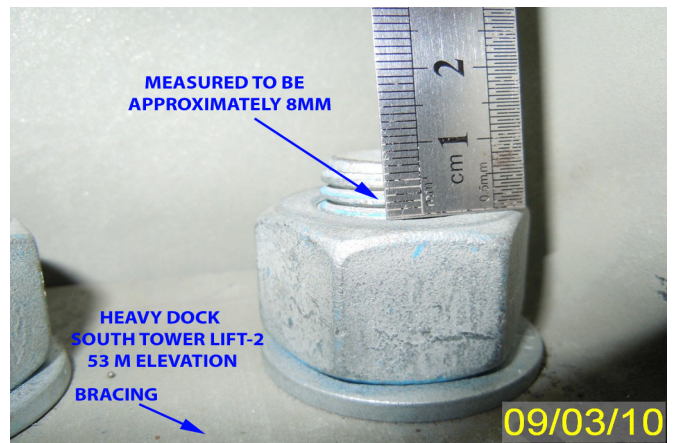
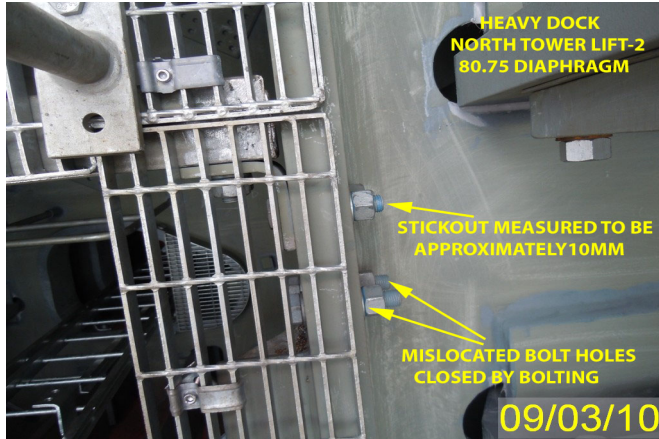
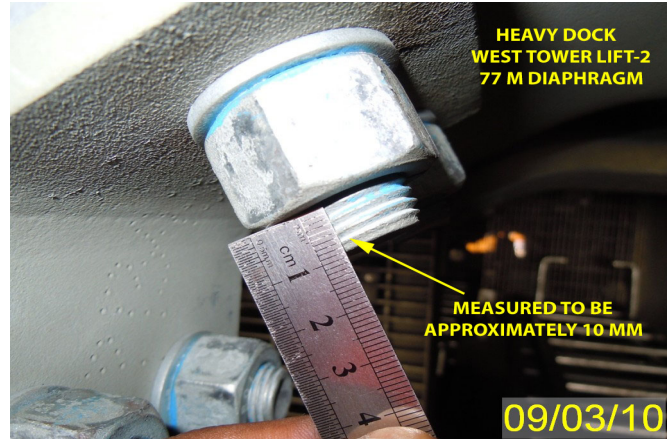
During random bolting survey verification in North, West, South & East Shafts of Lift 2, this Caltrans Quality Assurance (QA) Inspector discovered the following issues:

- Nearly most of the bolting in North, West, South and East shafts of lift-2 of grating support brackets, bracings and ladder support brackets, thread stickout measured to be beyond 6mm. This is not compliance with the Caltrans standard specifications.
- Approximately the measured lengths of the thread stickout ranges are from 8 to 10 mm.
- And for four (4) mislocated bolt holes on south and four (4) on north shafts at 80.75 M diaphragm's were closed by bolting. For these boltings thread stickout measured to be more than 15 mm.
- These Tower shafts are located on the ship.

“For all bolts, the threaded end projecting past the outer face of the nut (thread stickout), where first full formed thread is present, shall be at least flush with, but not more than 6 mm beyond, the outer face of the nut.”
